# New Hampshire Volunteer Lake Assessment Program

## 2002 Bi-Annual Report for Hermit Lake Sanbornton

NHDES Water Division Watershed Management Bureau 6 Hazen Drive Concord, NH 03301

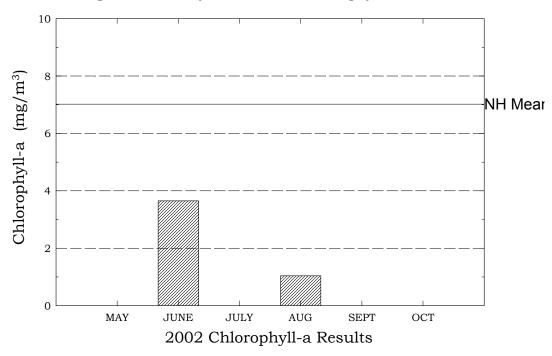
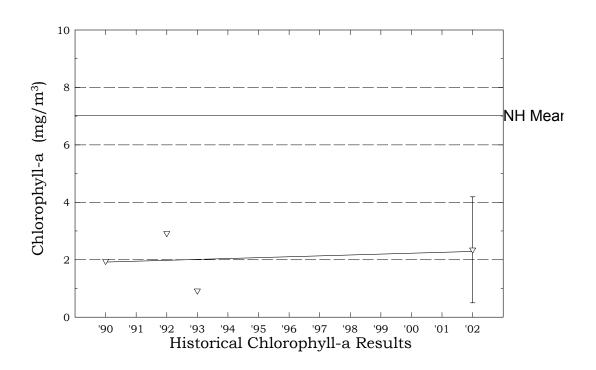
Figure 1. Monthly and Historical Chlorophyll-a Results

Figure 1 and Table 1: The graphs in Figure 1 (Appendix A) show the historical and current year chlorophyll-a concentration in the water column. Table 1 (Appendix B) lists the maximum, minimum, and mean concentration for each sampling season that the lake/pond has been monitored through the program.

The current year data (the top graph) show that the chlorophyll-a concentration *decreased* from June to August.

The historical data (the bottom graph) show that the 2002 chlorophyll-a mean is *less than* the state mean.

Overall, visual inspection of the historical data trend line (the bottom graph) **a variable** in-lake chlorophyll-a trend, meaning that the concentration has **fluctuated** since monitoring began in 1990. However, it is important to point out that each chlorophyll concentration has **been less** than the state median. We hope this continues!

While algae are naturally present in all lakes/ponds, an excessive or increasing amount of any type is not welcomed. In freshwater lakes/ponds, phosphorus is the nutrient that algae depend upon for growth. Therefore, algal concentrations may increase when there is an increase in nonpoint sources of nutrient loading from the watershed, or in-lake sources of phosphorus loading (such as phosphorus releases from the sediments). It is important to continually educate residents about how activities within the watershed can affect phosphorus loading and lake quality.

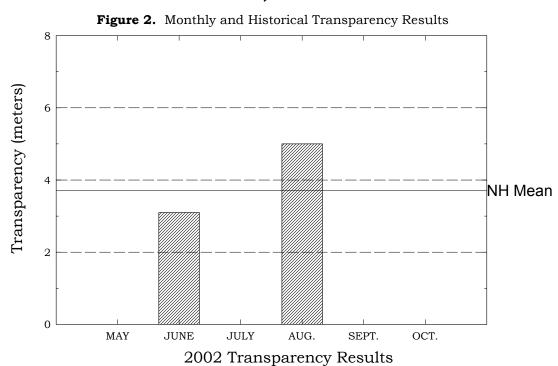
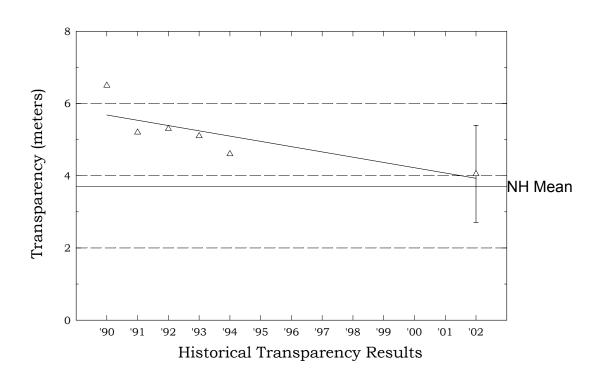
Figure 2 and Table 3: The graphs in Figure 2 (Appendix A) show historical and current year data for lake/pond transparency. Table 3 lists the maximum, minimum and mean transparency data for each sampling season that the lake/pond has been monitored through the program.

The current year data (the top graph) show that the in-lake transparency *increased greatly* from June to August. It is important to note that as the chlorophyll-a concentration decreased from June to August this season, the transparency increased. We

typically expect this inverse relationships in lakes. As the amount of algal cells in the water column decreases, the transparency increases.

The historical data (the bottom graph) show that the 2002 mean transparency is *slightly greater than* state mean.

Overall, visual inspection of the historical data trend line (the bottom graph) shows **a decreasing** trend for in-lake transparency, meaning that the transparency has **worsened** since monitoring began. However, please keep in mind that this trend is based on a limited data set.

Typically, high intensity rainfall causes erosion of sediments into lakes/ponds and streams, thus decreasing clarity. Efforts should continually be made to stabilize stream banks, lake/pond shorelines, disturbed soils within the watershed, and especially dirt roads located immediately adjacent to the edge of tributaries and the lake/pond. Guides to Best Management Practices designed to reduce, and possibly even eliminate, nonpoint source pollutants, such as sediment loading, are available from NHDES upon request.

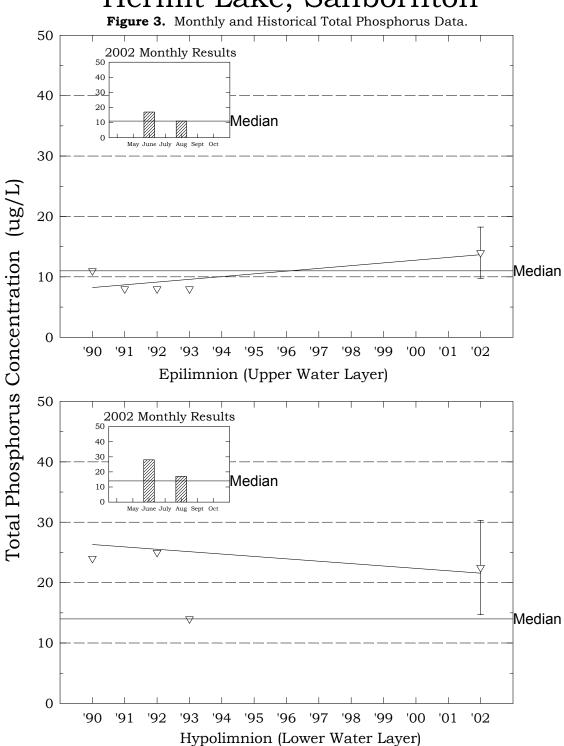
Figure 3 and Table 8: The graphs in Figure 3 (Appendix A) show the amounts of phosphorus in the epilimnion (the upper layer) and the hypolimnion (the lower layer); the inset graphs show current year data. Table 8 (Appendix B) lists the annual maximum, minimum, and median concentration for each deep spot layer and each tributary since the lake/pond has joined the program.

The current year data for the epilimnion (the top inset graph) and the hypolimnion (bottom inset graph) show that the total phosphorus concentration *decreased* from June to August.

The historical data show that the 2002 mean epilimnetic total phosphorus concentration is **slightly greater than** the state median.

The historical data show that the 2002 mean hypolimnetic total phosphorus concentration is *greater than* the state median.

Overall, visual inspection of the historical data trend line for the epilimnion show **a** slightly increasing total phosphorus trend, which means that the concentration has slightly worsened in the epilimnion since monitoring began.

Overall, visual inspection of the historical data trend line for the hypolimnion shows **a variable** total phosphorus trend, which means that the concentration has **fluctuated** in the hypolimnion since monitoring began.

One of the most important approaches to reducing phosphorus loading to a waterbody is to continually educate watershed residents about its sources and how excessive amounts can adversely impact the ecology and value of lakes and ponds. Phosphorus sources within a lake or pond's watershed typically include septic systems, animal waste, lawn fertilizer, road and construction erosion, and natural wetlands. If you would like to educate watershed residents about how they can help to reduce phosphorus loading into the lake/pond, please contact the VLAP Coordinator.
